Project Erebus Floating Offshore Wind Farm

Notice to Mariners

NtM Number	Erebus/003 v21.0
Date of Issue	20/01/2022

Recovery of Moorings

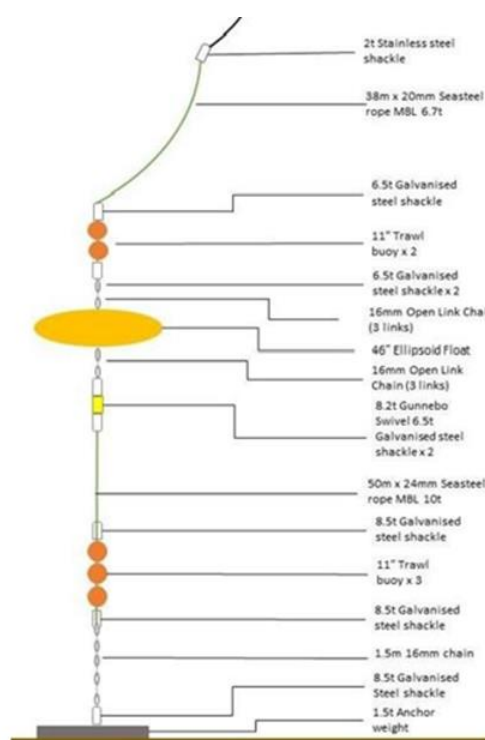
An image of the two mooring systems on the seabed is shown below. The first 15 m from the upper mooring has been recovered. The remaining mooring components start from the 38 mm x 20 mm seasteel to the anchor weight on the seabed.

A Remotely Operated Vehicle (ROV) will be deployed to identify the moorings. The moorings will then be brought to deck and transported to shore.
